Manhole Inspection Summary

Manhole # S31CC_046MH

Inspection ☐ Is Incomplete Rating: **3) Fair**

Location Address: **201 PRESTON ST**

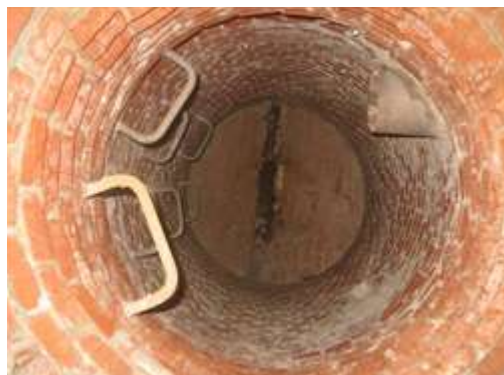
Top View

Channel debris.

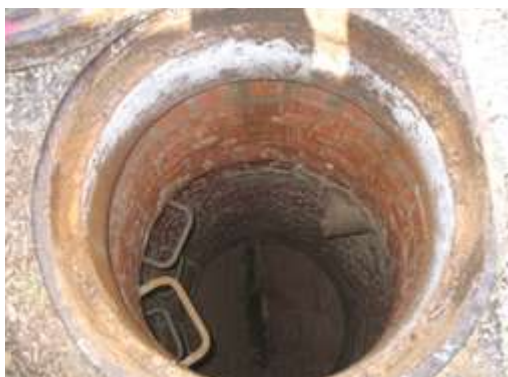
Defect

Frame leaks. Adjustment, Corbel and Barrel infiltration.

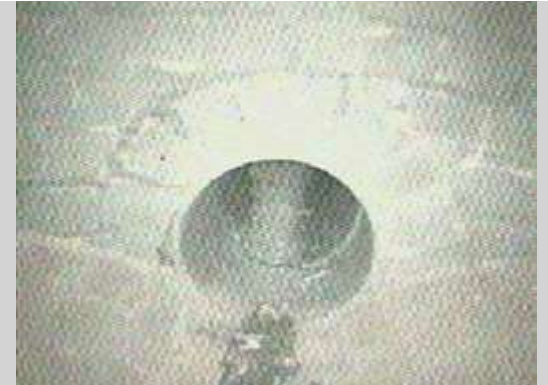
8 in. Circular Gravity Sewer Pipe Out @ 12 O'Clock

Infiltration: **Evidence**

Connects To: **Connecting Node Not Available**
